# Intel<sup>®</sup> Celeron<sup>®</sup> Processor Specification Update

Release Date: January 2002

Order Number: 243748-040

The Intel<sup>®</sup> Celeron<sup>®</sup> processor may contain design defects or errors known as errata, which may cause the product to deviate from published specifications. Current characterized errata are documented in this Specification Update.

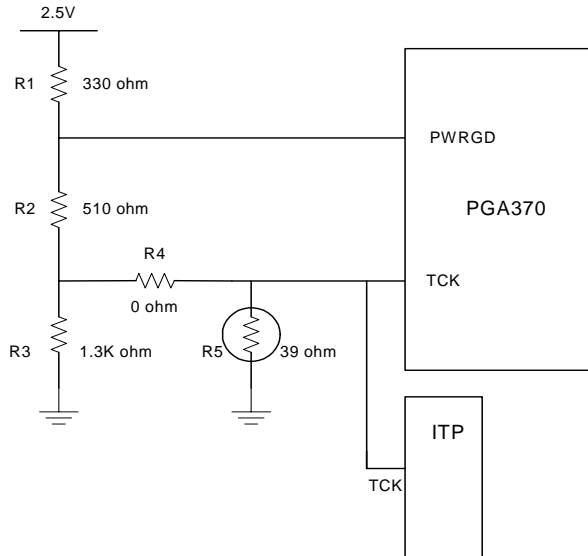
Celeron® on 0.13 micron Processor 256K Platforms Workaround

In addition, the example workaround circuits shown do not support production motherboard test methodologies that require the use of the processor JTAG/TAP port. Alternative workaround solutions must be found if such test capability is required.

For Production Boards:  
*Depopulate R5*

To use ITP:  
*Install R5, Depopulate R4*
